## Lessons Learned from Waldo Canyon

FIRE ADAPTED COMMUNITIES  
MITIGATION ASSESSMENT TEAM FINDINGS

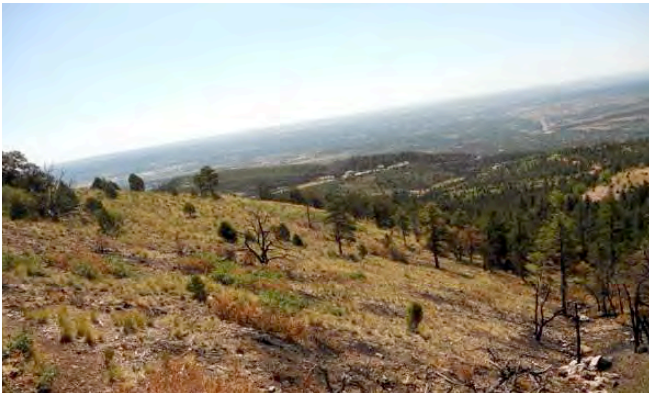
In places where there had been a continuous layer of dry, shrubby fuels (decadent Gambel oak), the treatment broke the layer into clumps (Figure 1).

*Figure 1: Solitude Park parcel dominated by Gambel oak, where the results of the fuel treatment by breaking up a continuous layer of shrubby fuels, are still obvious. The Waldo Canyon Fire spread to this treated area. It was extinguished before it spread to homes. Source: USDA Forest Service.*

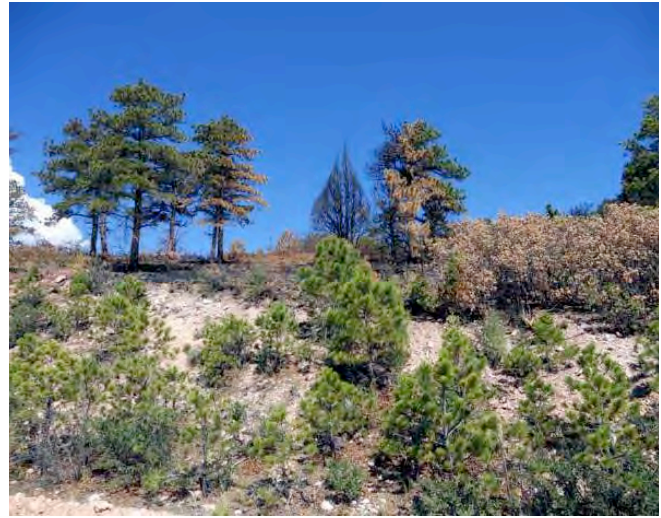
*Figure 2: The wildfire stopped or was extinguished in the middle of this treated area. Source: USDA Forest Service.*

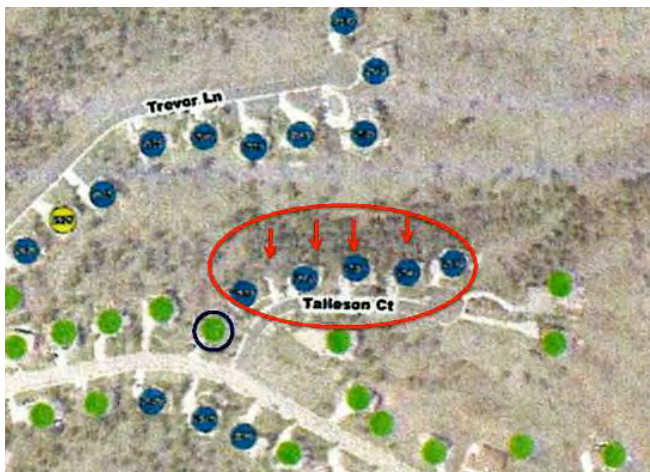
Figure 5: Five homes on Talleson Court were destroyed (red circled). These homes were located at the top of a slope and each had overhanging decks. One home suffered minor damage (blue circled).

first igniting a wooded area within the community with a subsequent direct flame contact exposure to the home (Figure 5). These homes were located at the top of a steep slope (> 30%) and were rated as being in an “extreme” hazard zone by the Colorado Springs Division of the Fire Marshal.

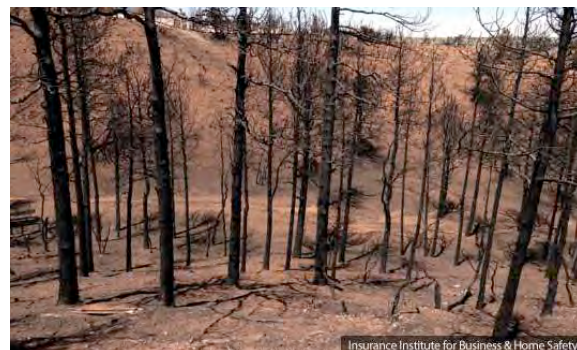
Each home had a deck overhanging the slope. Figure 6 shows a view from the top of slope where the deck was located, looking down slope. The spot fire in the wooded area crowned and separation from homes to the trees was insufficient to avoid a direct flame contact to the overhanging decks. Fire then spread from the deck to the interior of the homes. An interview with a homeowner, who was present during the site visit and whose house was destroyed told members of the assessment team that the house had a lower and upper deck, and that one deck was constructed using wood, while the other deck was built using a wood-plastic composite decking product.

Figure 6: View down slope from a Talleson Court home. Note the lack of needle vegetation on the trees, indicating the fire crowned in these trees. Source: IBHS.

Mitigation strategies for this threat would include thinning trees and removing ladder fuels. Building a cross-slope retaining wall using noncombustible materials down-slope from the homes could also be an effective strategy for shorter brush-type vegetation<sup>4</sup>. However, this would not work in a wooded area with taller trees since a crown fire would burn over top a typical retaining wall. This mitigation strategy is an example of where a communitywide effort would produce the most effective results.

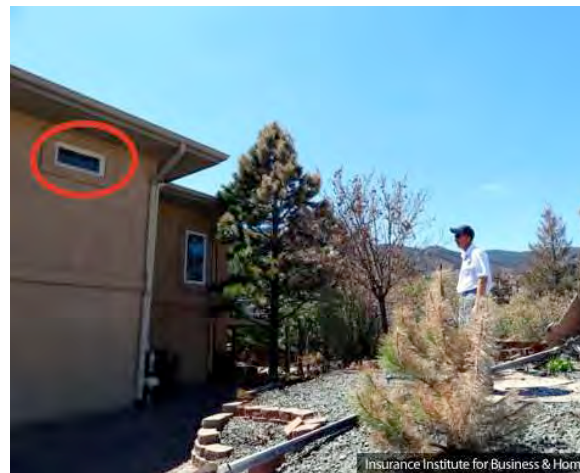
Figure 7 depicts a home that suffered minor damage from radiant heat. This home was located approximately 30 feet from the home that was destroyed. Damage consisted of deformed vinyl frames in two windows and cracked outer glass panes in the same windows. A near-home pine tree showed signs of needle scorch. No damage was observed on the stucco-type exterior cladding. In this case, because of the limited damage to the vinyl frame windows, and because the damage was caused by the radiant heat exposure from the adjacent home, human intervention wasn't likely. Because the glass in the windows did not completely fail (i.e., the outer glass pane remained intact and the frame did not ignite), ember entry into the home did not occur.

It should be noted that, with the exception of the pine tree located near the home and a small bush in the interior corner, the defensible space on this side of the house was good (Figure 7). A noncombustible gravel product was used within 10 feet of the house. Any ember deposition and accumulation would have been on this material.

*Figure 7: This damaged Talleson Court home was approximately 30 feet from a destroyed home. Two windows were damaged (one is circled in red; another window of the same size is located to the left of the one shown). The tall pine tree had lower branches removed and noncombustible gravel was used within approximately 10 feet from the house. Note the scorch on the destroyed home side of the pine tree and small tree in the foreground. Source: IBHS.*

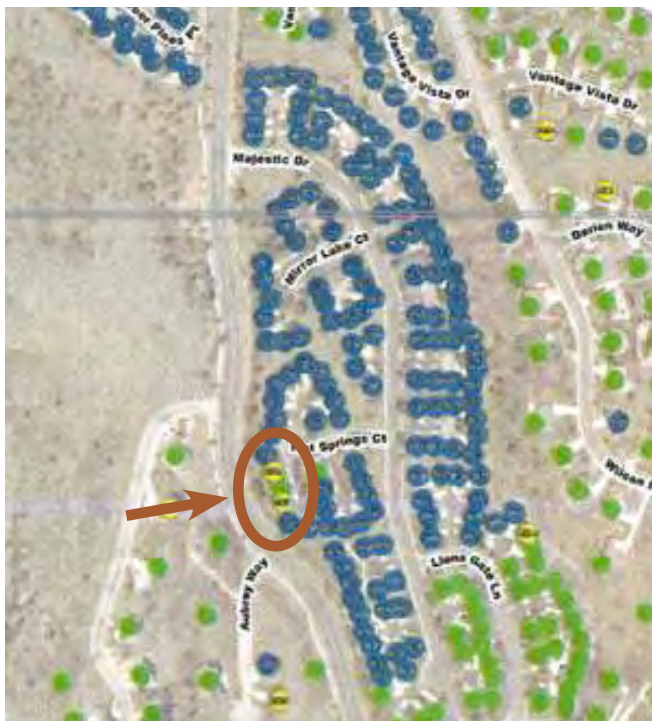
Figure 10: Majestic Drive area of the Mountain Shadows neighborhood showing destroyed (blue), damaged (yellow) and undamaged (green) homes, as shown in the preliminary damage assessment survey map. An undamaged home in the middle identified by an arrow was not included in this field assessment. Source: Colorado Springs Division of the Fire Marshal.

Ignition of the destroyed home at 2551 Hot Springs Court, shown as the upper most home in the red circled area in Figure 10, was either from the adjacent destroyed home located 16 foot away or through direct ember ignition. Defensible space was very good; rock mulch surrounded the home and the balance of the property consisted of irrigated lawn. The wood “half wine-barrel” planters were either largely undamaged, or burned on the house-facing side, indicating exposure from the burning house.

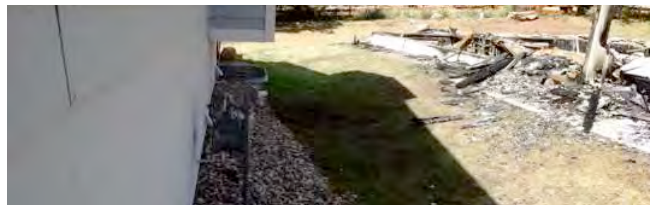
Figure 11: The distance between the destroyed home on the left and the damaged home on the right was approximately 16 feet. Source: IBHS.

The relatively minor damage to the side of the home shown in Figure 11 is unusual given the close between home spacing. The lack of charring or scorch on the siding and shrubs (not shown in Figure 11) indicated that the destroyed house largely burned within the interior and then collapsed before involving most of the exterior. This would imply minimal window area on the sides facing the damaged home. A portion of the unconsumed wood-framed wall was standing on the side of the destroyed home facing the damaged home. The terrain at this location was relatively flat which could also help minimize exposure to the adjacent home<sup>6</sup>.

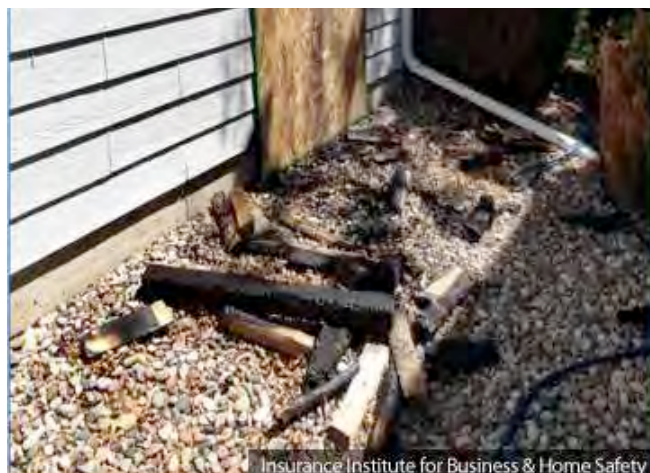
Figure 12: Embers ignited a firewood pile located next to the garage of this home. The direct flame contact exposure from the burning firewood ignited the composite wood (hardboard) siding product. Source: IBHS.

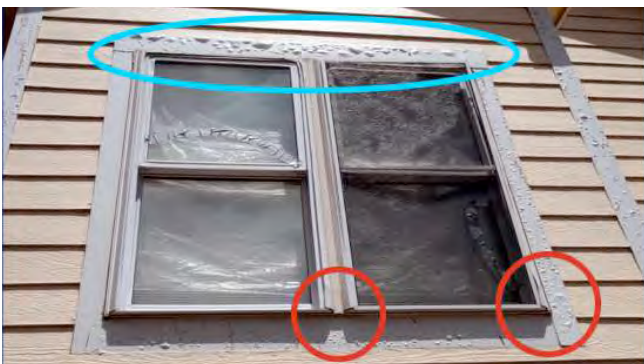
Damage to the remaining non-destroyed home on this court consisted of bubbling paint on window and other trim boards and a deformed vinyl window frame (Figure 13). The distance to the destroyed home was approximately 20 feet.

Figure 13: Radiant heat from the burning home, which was destroyed and was located 20 feet from this damaged home, was sufficient to cause paint on the wood trim to bubble (circled blue) and thinner components on the vinyl window frame to deform (circled red). Source: IBHS.

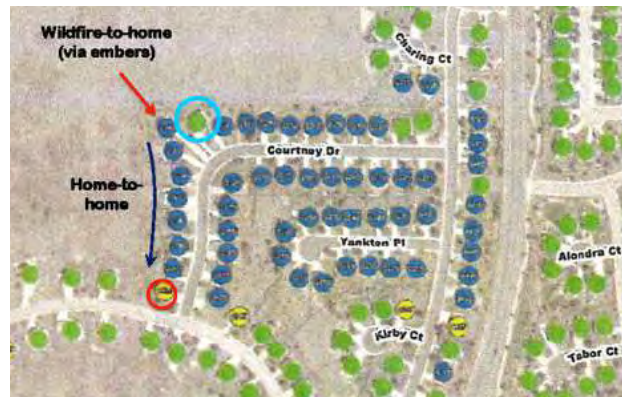
Figure 14: Homes on Courtney Drive that were destroyed by home-to-home spread after an initial wildfire-to-home ignition (indicated with red arrow). One home at the top of slope (red circled) suffered minor damage. The home to the east (right) of the wildfire-to-home, shown as a non-damaged green dot in this figure (blue circled), also had minor damage. Source: IBHS.

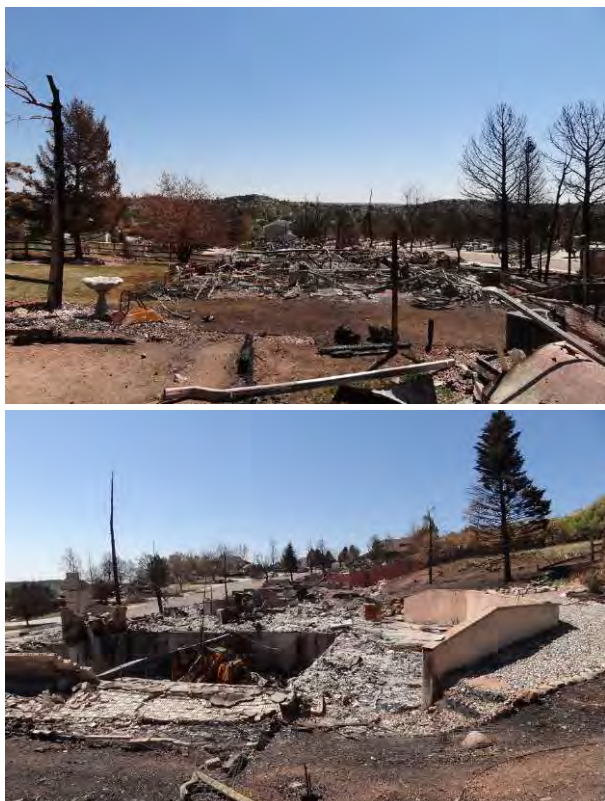
Figure 15: A composite figure showing destroyed Courtney Drive homes, as viewed from upslope and down slope different perspectives. Source: IBHS.

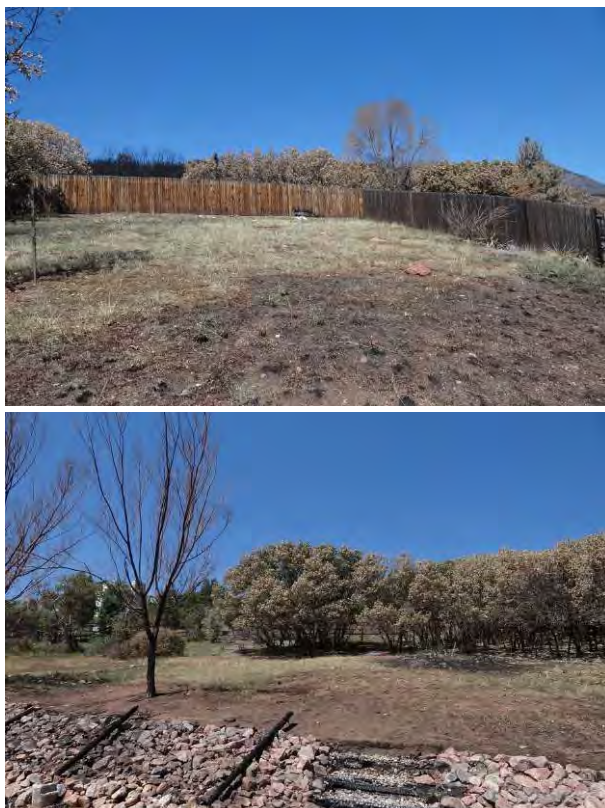
The defensible space around the destroyed homes was adequate. Observations during the site visit showed that burned and scorched vegetation and other combustibles were from radiant heat and / or fire spread out from the burning homes rather than the wildfire (Figures 16 and 17).

Figure 16: Composite figure of backyards of two destroyed homes on Courtney Drive; photos taken from the home site location. Damage to vegetation and other combustible components was from burning home, not wildfire. Source: IBHS.

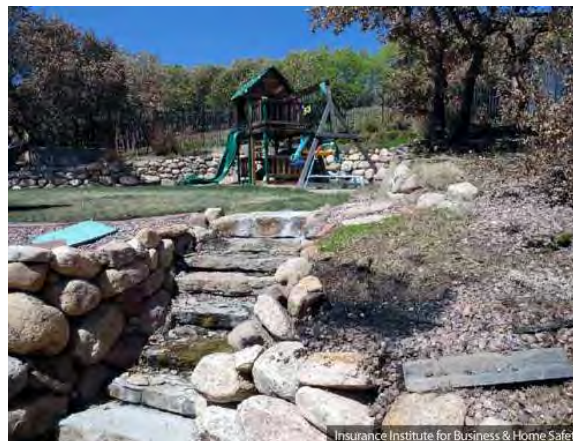
Figure 17: Damage to the play structure slide resulting from radiant heat exposure from the burning Courtney Drive home. Deformation of plastic components (slide and roof) was observed. Scorch or charring of wood structural support members was not observed. Source: IBHS.

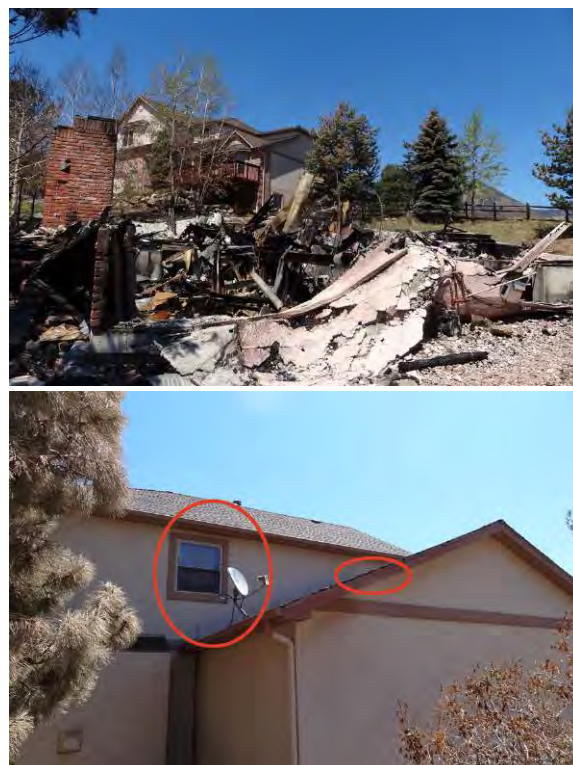
Figure 18: A composite figure of two damaged homes on the west side of Courtney Dr. The up-slope home is above and the down-slope home below. The charred combustible siding in the up-slope home is not visible in this figure. The damaged components in the down-slope home are circled. Source: IBHS.

The mitigation strategies here are the same as those recommended by Maranghides and Johnsson referenced in the Majestic Drive section of this report.

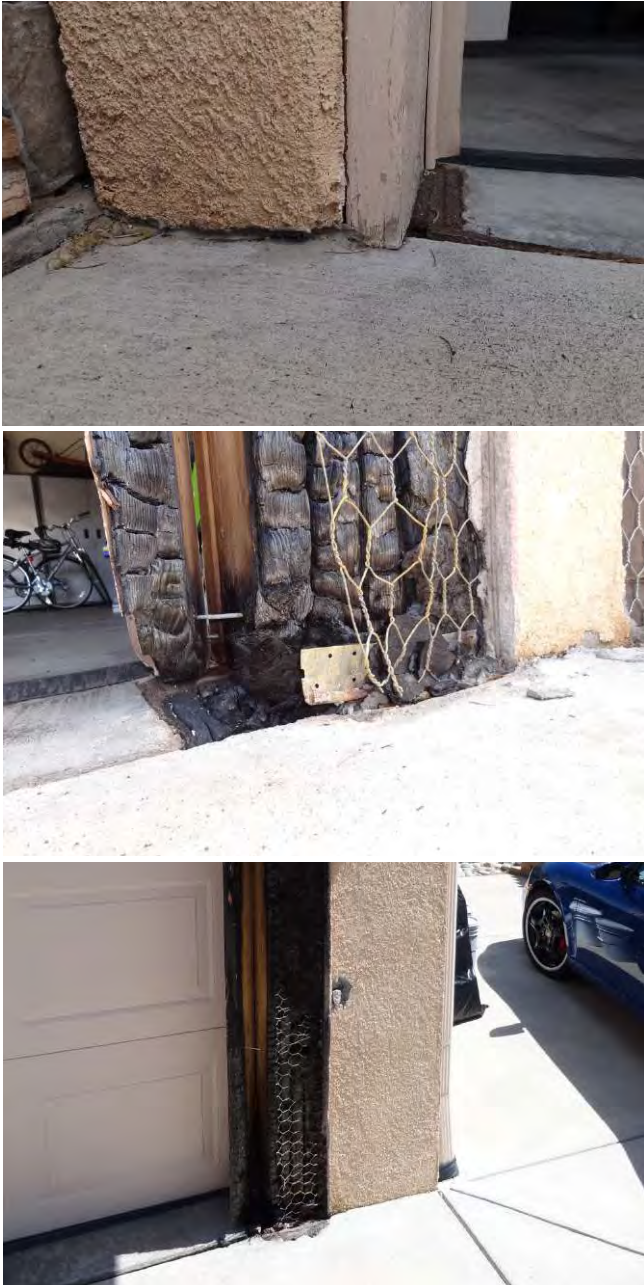
*Figure 19: Photographs of the left, middle and right side columns of the two-car garage at a home on Lanagan Street. Note the low clearance between the concrete driveway and the EIFS system, as shown in the left-hand side column. The metal weep screed is visible at the base of the middle column. Source: IBHS.*

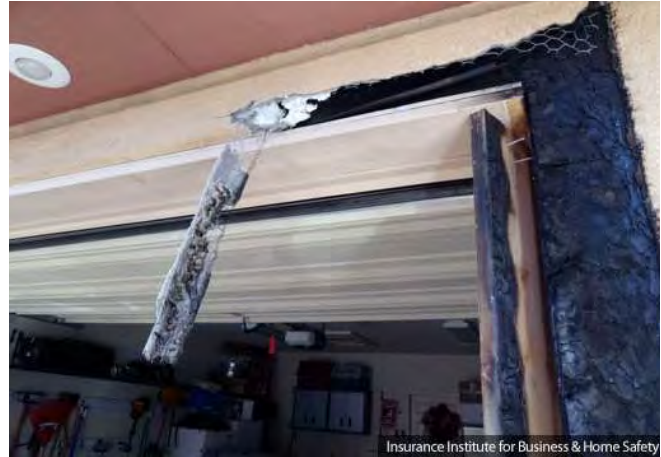
*Figure 20: The components of this EIFS system include a noncombustible stucco outer coating, and inner layers of combustible foam insulation, wood-based sheathing, and wood framing. Source: IBHS.*

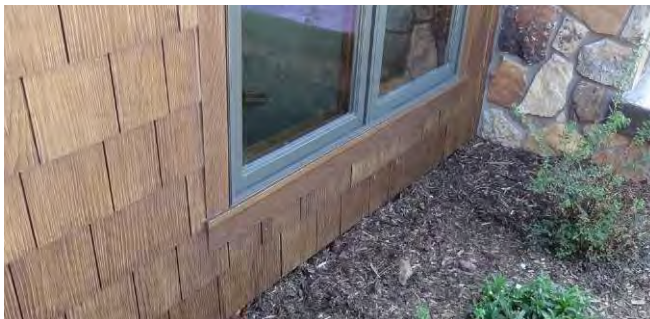
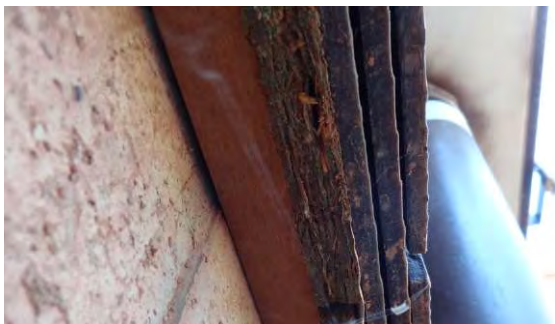
*Figure 21: The siding on this home was a noncombustible fiber-cement shingle product (upper photo). The assembly at the base of the wall, showing combustible wood-based sheathing, is shown in the lower photo. Source: IBHS.*

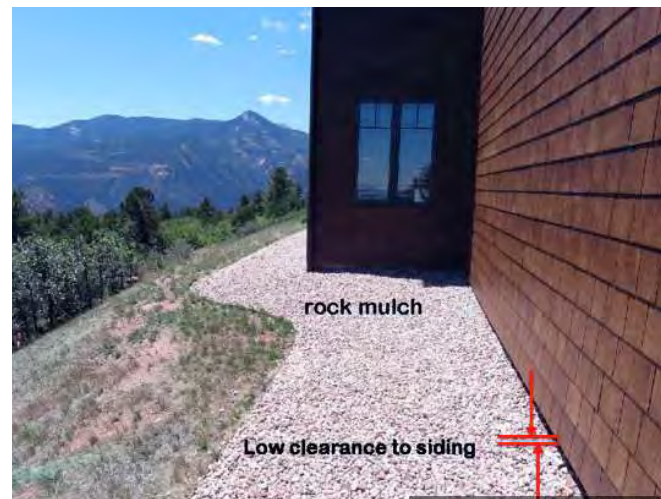
A noncombustible rock mulch product was used on the back side of this home (Figure 22), along with a fiber-cement shingle product. As was the case of the Lanagan Street home, the ground-to-siding clearance for this home was minimal and accumulation of embers at the base of the wall could result in the ignition of the underlying wood-based sheathing. In this case, the foam insulation was not included in the assembly.

*Figure 22: The back side of the home on Outer Vista Point Road. Noncombustible rock mulch and fiber-cement shingle siding products were used. The low clearance may allow for the underlying wood-based sheathing product to be vulnerable to ember accumulation at the base of the wall. Source: IBHS.*

In each of the construction conditions discussed in this section, increasing the ground-to-siding clearance would result in a less vulnerable assembly. Mitigation strategies for the Lanagan Street home would include increasing the height of the concrete foundation to increase the distance between the driveway and the beginning of the EIFS cladding system. Use of a six-inch driveway-to-EIFS clearance would correspond to the already code-required earth-to-wood clearance for wood-based siding products. A six-inch clearance may or may not be the optimal separation to avoid ember accumulation-related damage via smoldering and / or flaming combustion, but based on these observations, it would be the preferred option to the observed much lower earth-(or ground)-to-siding clearances.

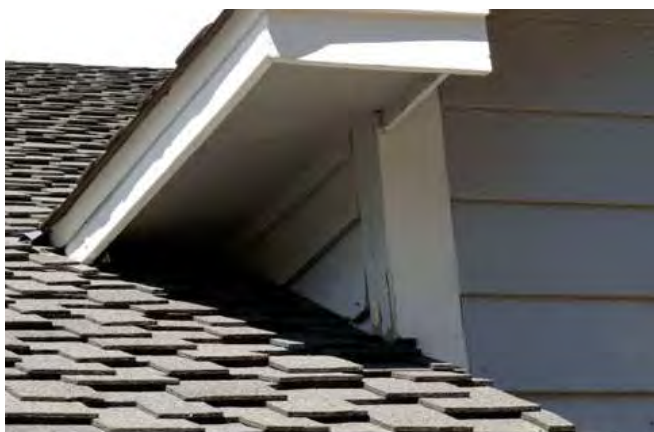
A similar vulnerability can also occur on complex roofs, as shown in Figure 23. This detail was observed on a home in the Majestic Drive area, but is common on complex roof systems. The code required clearance between the roof and wood and wood-based siding is two-inches (less than that required for earth-to-wood siding). Ember ignition of vegetation debris in gutters and on the roof at roof-to-wall intersections has been demonstrated<sup>8</sup> as has the ignition of wood decking, without an accumulation of vegetative debris<sup>9</sup>.

Figure 23: The roof-to-siding return on this complex roof consists of a composite wood (hardboard) siding product and a Class A fire-rated asphalt composition shingle roof covering. Even without vegetative debris at the roof-to-wall intersection, an accumulation of embers could result in ignition of the wood-based siding. Source: IBHS.

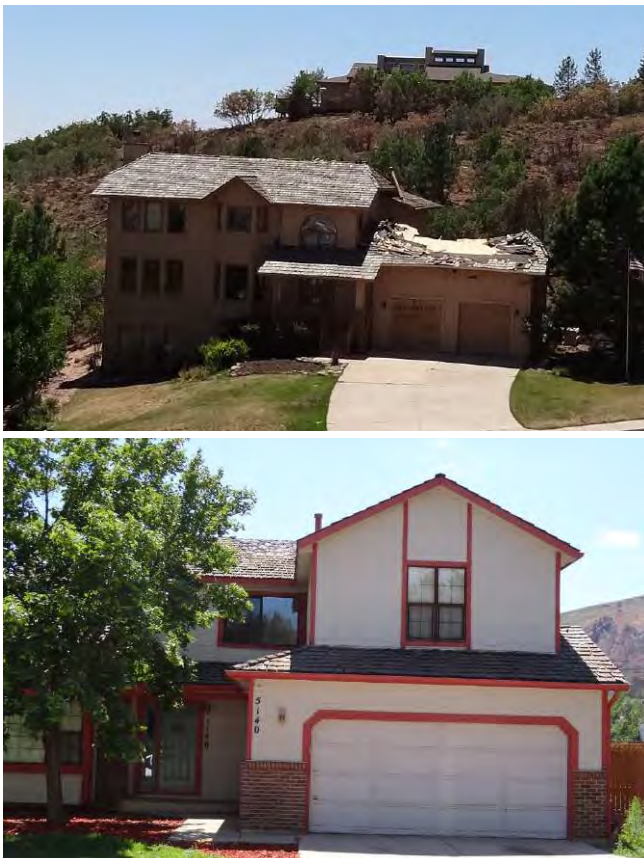
Two homes in the Mountain Shadows neighborhood, both located well-away from the perimeter of the community (Figure 24), had wood shake roofs that were ignited by wind-blown embers (Figure 25). The actions of firefighters saved each home, supporting findings from many other post-fire surveys and investigations of the benefit of intervention / suppression efforts in saving homes that have ignited. Fires in homes that are destroyed start out as relatively small fires and can be extinguished if discovered early. The Rossmere Street photo in Figure 25 shows three neighboring homes, with the middle one having the wood shake roof. The two adjacent homes have a Class A fire rated roof covering. These homes were not damaged. Given the proximity of the homes to each other, the ember exposure to each was likely similar, demonstrating the importance of replacing a wood shake roof covering.

Figure 25: Homes on Rossmere Street (upper) and Champagne Drive (lower), each had wood shake roof coverings that were ignited by wind-blown embers. Source: IBHS.

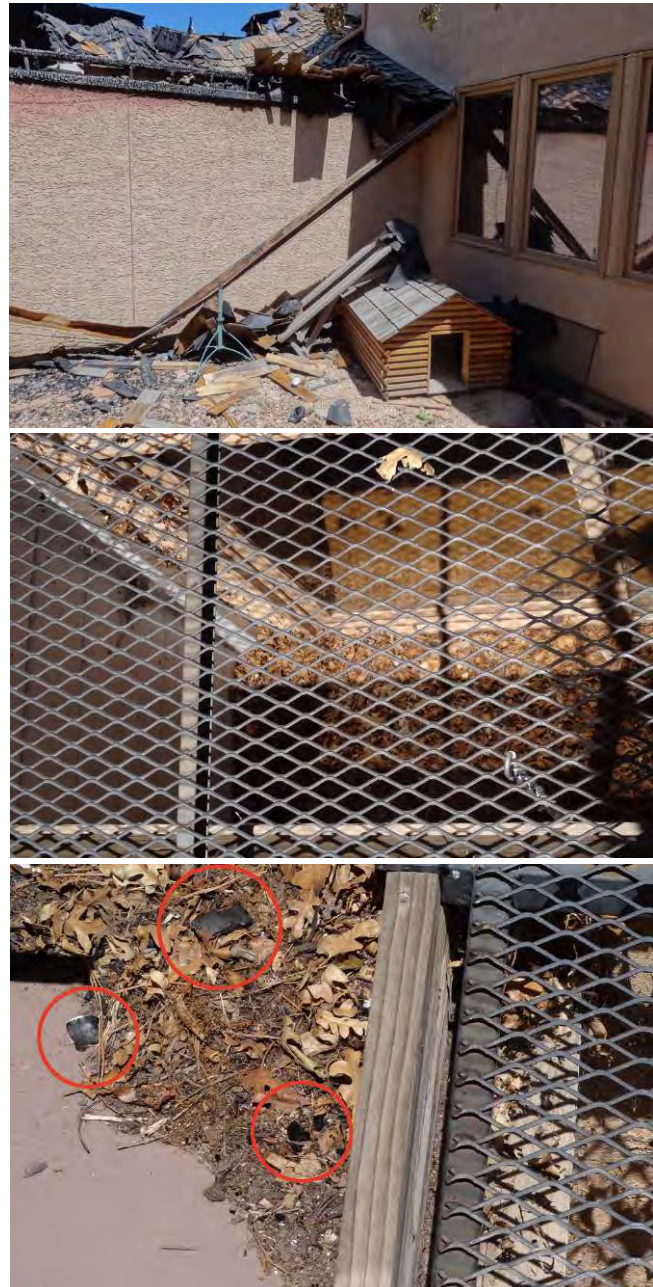
Figure 26: Combustible materials were present in the near-home zone of the Rossmere Street home. Embers are evident in the right-hand middle photo (embers circled in red). Source: IBHS.

Each of the two homes with wood shake roof coverings also had relatively poor defensible space in the near-home, 0-5 foot zone (Figures 26 and 27), and an ember exposure to near-home combustible materials was evident. The front of the Rossmere Street home had a design feature that,

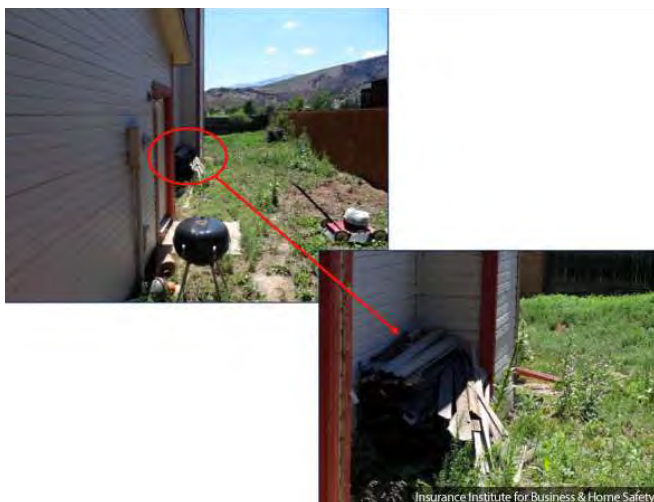
Figure 27: Combustible materials were present in the near-home zone of the Champagne Drive home. Source: IBHS.

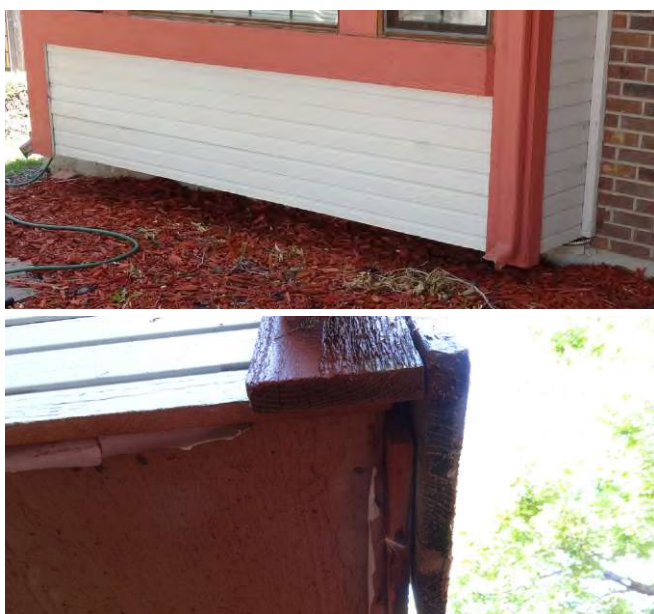
coupled with the wood mulch on the ground, resulted in a vulnerability to the home (Figure 28). This condition is very similar to the previously discussed earth-to-wood condition observed at other homes in Mountain Shadows and Cedar Heights. Although an ember exposure occurred in this area at the front of the home, ignition of mulch was not evident. Although any of these could have resulted in ignition of the home indirectly, given a large enough ember exposure, the wood shake roof was the most vulnerable feature on these homes.

Figure 28: The "bump out" design feature at the front of the Rossmere Street home would be been vulnerable, if the wood mulch had been ignited by the observed ember exposure. Given the low earth-to-wood clearance, flame spread to the bump out would have provided a flame contact exposure to the combustible underside feature. Source: IBHS.
