## Lessons Learned from Waldo Canyon

FIRE ADAPTED COMMUNITIES  
MITIGATION ASSESSMENT TEAM FINDINGS

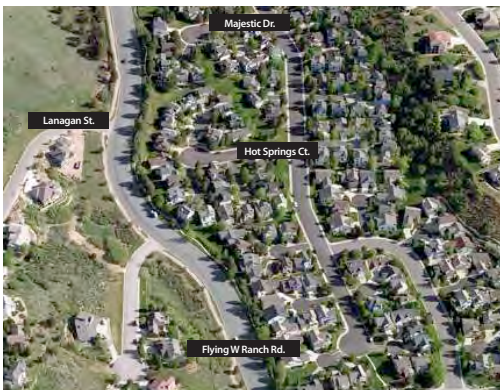
Aerial photographs of the Majestic Drive area before and after the fire are shown in Figures 8 and 9. As shown in Figure 8, the fire burned down to Flying W Ranch Road, burning the vegetation on the west side of the road (left-hand side in Figure 8). Flying W Ranch Road is a major thoroughfare through the community and is approximately the width of a four-lane road: it consists of two lanes with a center common turning lane and wide, paved shoulders. Because of the width of Flying W Ranch Road, the homes in this area ignited either from direct or indirect ember exposure or home-to-home spread. Although it was not determined which of the homes in the Majestic Drive area were ignited by embers and which were specifically ignited through home-to-home fire spread, because of the relatively close between-home spacing, it is probable that many of the 135 homes destroyed in this area were the result of home-to-home fire spread.

Figure 8: Majestic Drive area of the Mountain Shadows neighborhood prior to the Waldo Canyon Fire. Source: Google Maps.

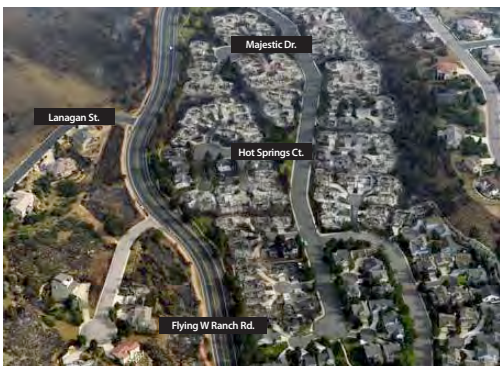
Figure 9: Majestic Drive area of the Mountain Shadows neighborhood after the Waldo Canyon Fire. Source: Colorado Springs Division of the Fire Marshal.

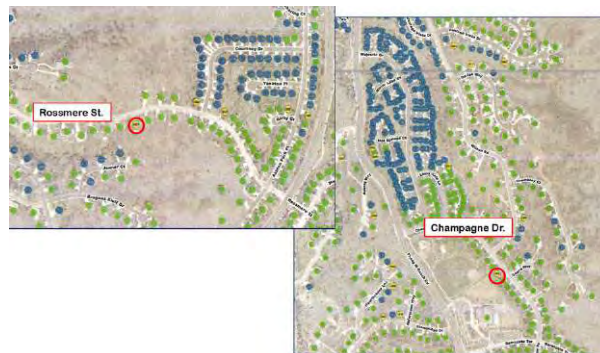
Figure 24: Location of the Rossmere Street and Champagne Drive homes (circled red) within the Mountain Shadows community. Source: IBHS.

Two homes in the Mountain Shadows neighborhood, both located well-away from the perimeter of the community (Figure 24), had wood shake roofs that were ignited by wind-blown embers (Figure 25). The actions of firefighters saved each home, supporting findings from many other post-fire surveys and investigations of the benefit of intervention / suppression efforts in saving homes that have ignited. Fires in homes that are destroyed start out as relatively small fires and can be extinguished if discovered early. The Rossmere Street photo in Figure 25 shows three neighboring homes, with the middle one having the wood shake roof. The two adjacent homes have a Class A fire rated roof covering. These homes were not damaged. Given the proximity of the homes to each other, the ember exposure to each was likely similar, demonstrating the importance of replacing a wood shake roof covering.

The vulnerability of (non fire-retardant treated) wood shake roofs has been documented. Removal of wood shake roofs and replacement with Class A fire-rated roof coverings has been a strong recommendation by the fire service and others involved in homeowner educational programs for a number of years. The roof represents a large relatively horizontal surface that can and will collect embers. Highly combustible roof coverings, such as wood-shake coverings, can be easily ignited. In many locations, including Colorado Springs, use of wood shake roofs in wildfire-prone areas is not allowed when a roof covering is replaced. Although many homeowners in the Colorado Springs have replaced their wood shake roofs in recent years, many homes still have this type of roof covering.
